Town of Wilton

Stormwater Enforcement Action Summary

Case: 21-01 Falcon Ridge Development Sediment Discharge into Frog Pond

Stormwater Construction Inspection Form

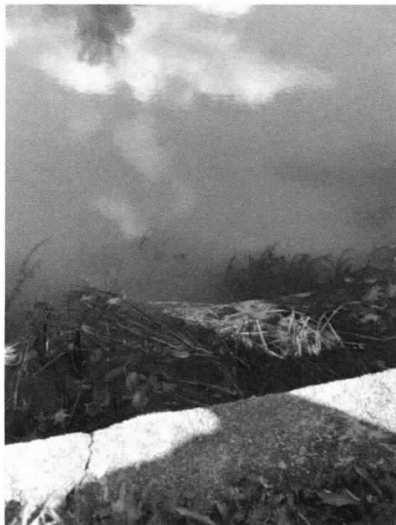
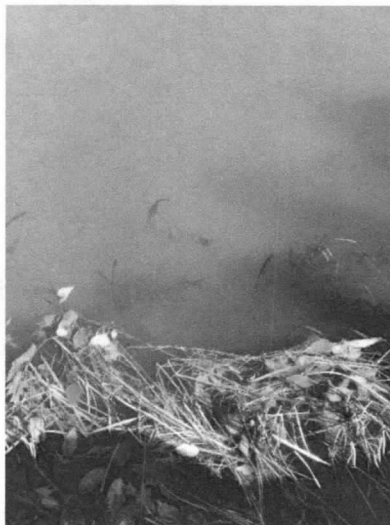
November 16, 2021, Michele Decoteau reviewed the water flowing over the dam and found some sediment. These photos are looking down on the pond from before water flows over the dam. This is the dam located on lot D-093 in Wilton. Approximate coordinates N 42° 50.721' W071° 43.764.

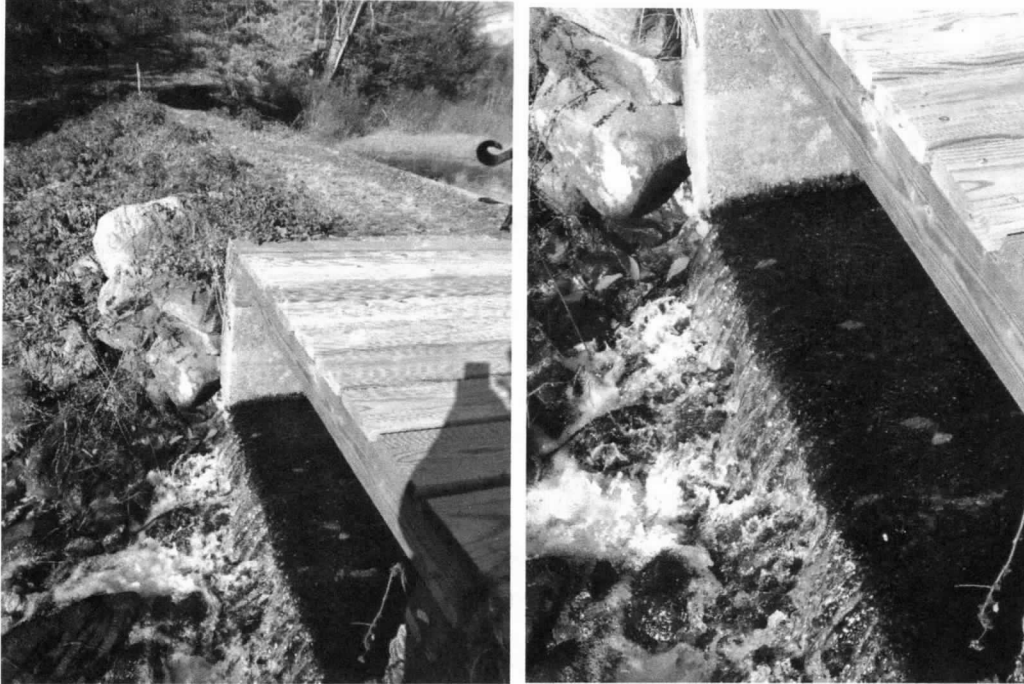
The water flowing over the dam was far clearer than what was witnessed by observers in October 2021.

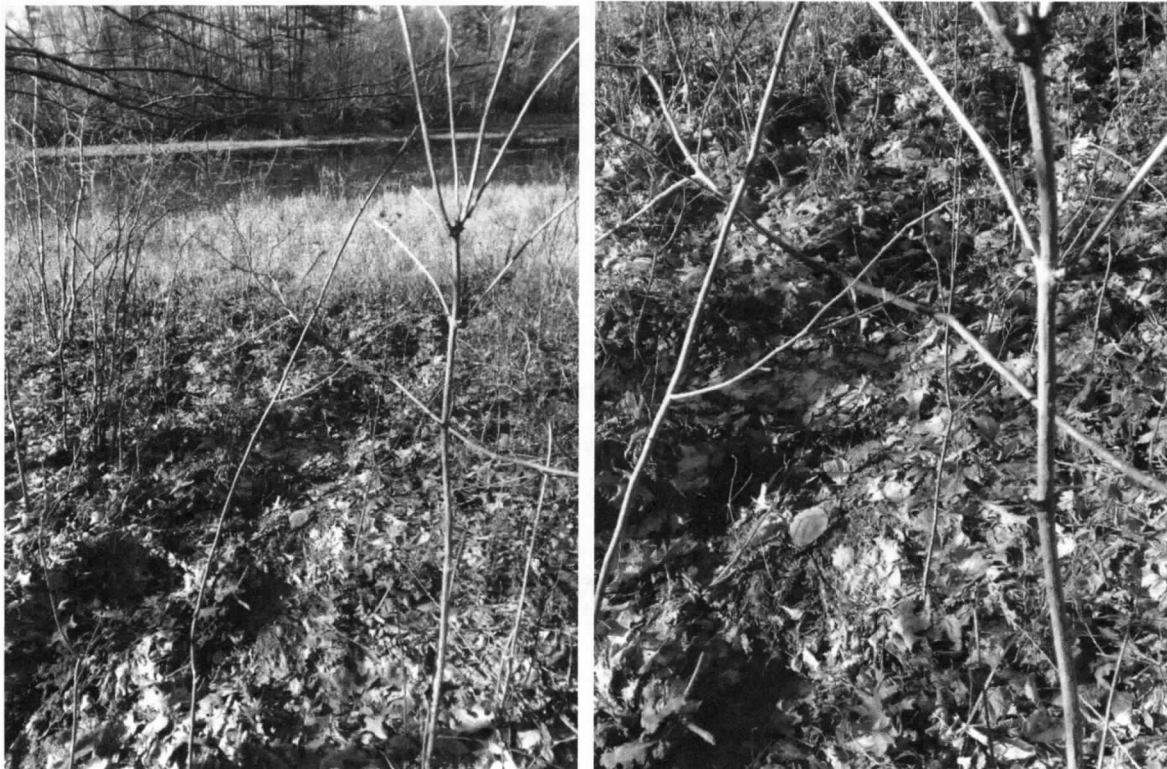
After walking around the pond, it was clear where there was silt entering the pond. This is on lot 3-4 Milford. Approximate coordinates 42°50'44.8"N 71°43'43.8"W

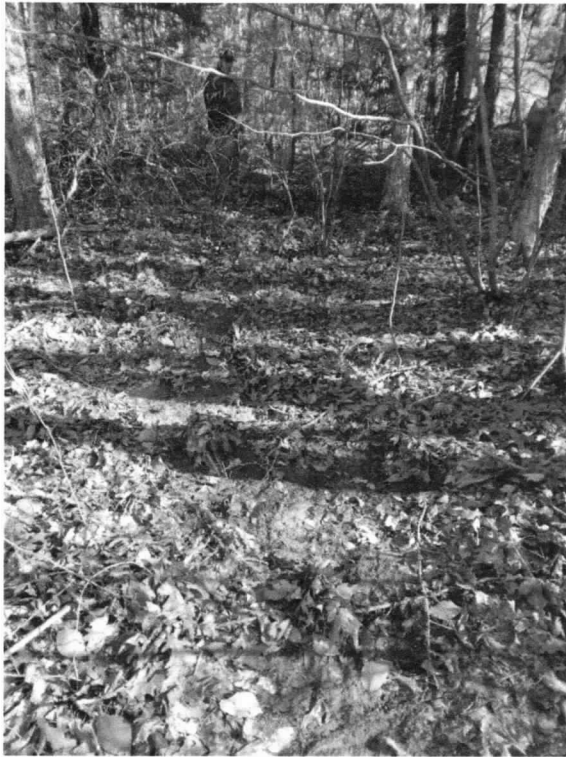
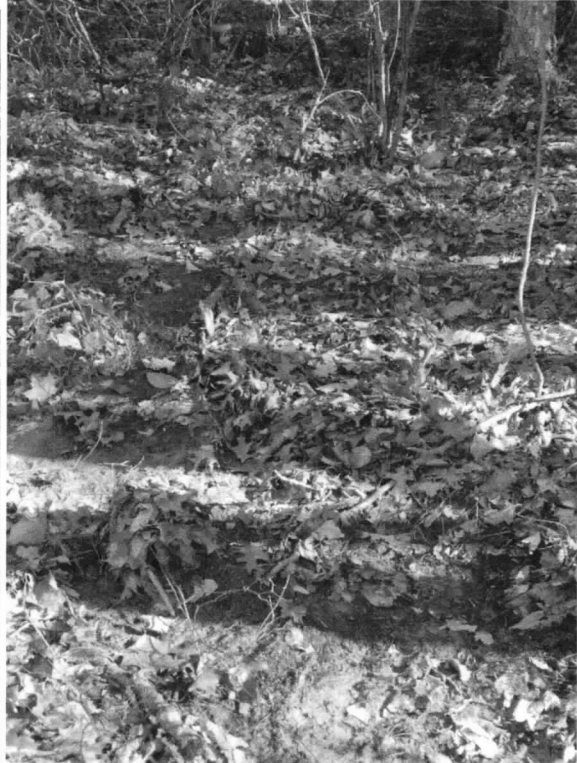
We followed the trail of material uphill to a fire access road. This road is also on Lot 3-4 in Milford.

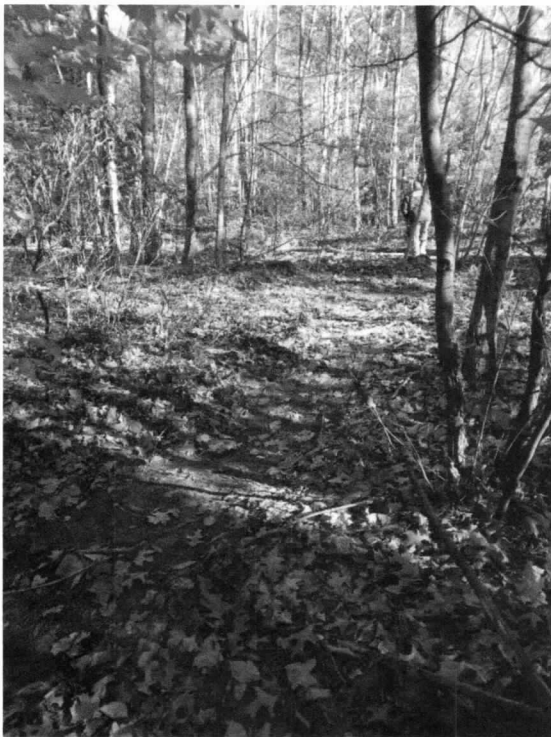
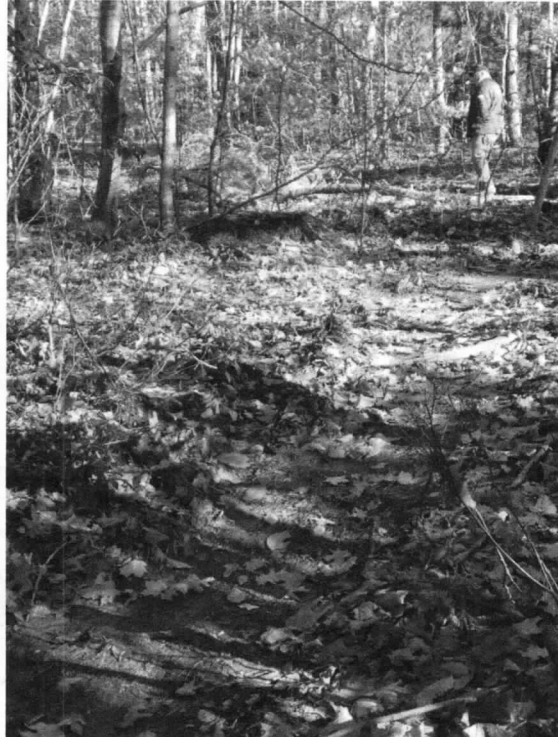
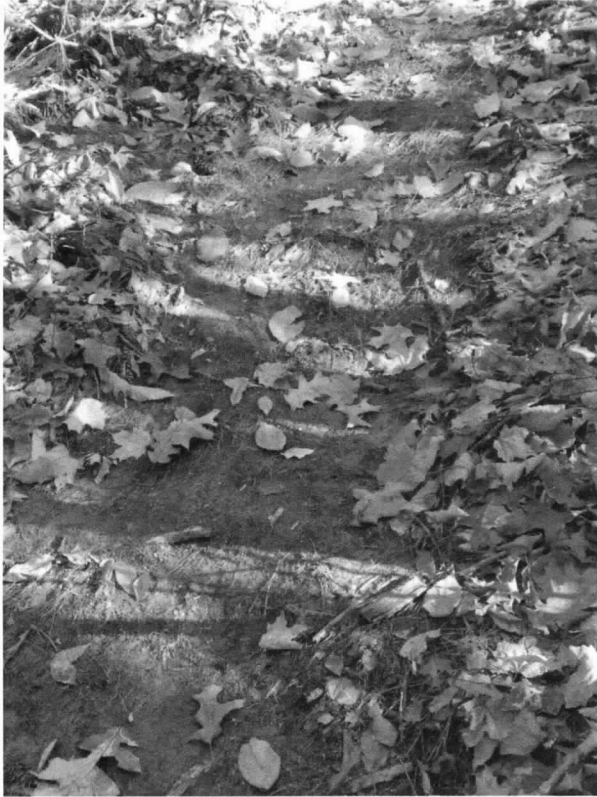
Once on the road, there was evidence of flow of water on the road.

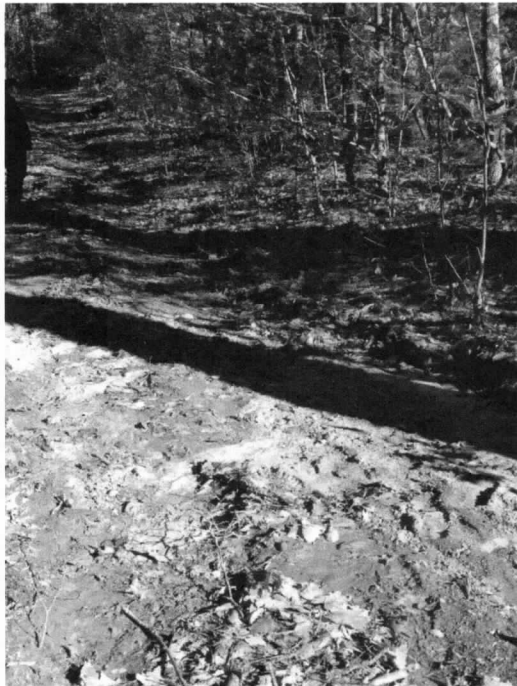
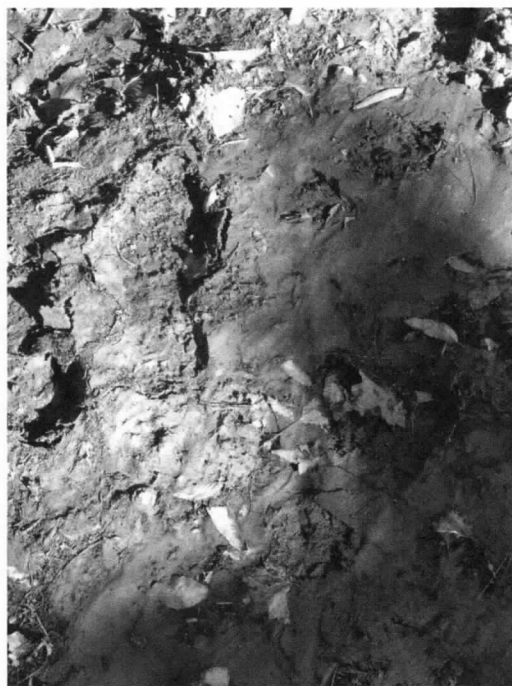
On the fire road was very fine sediment.

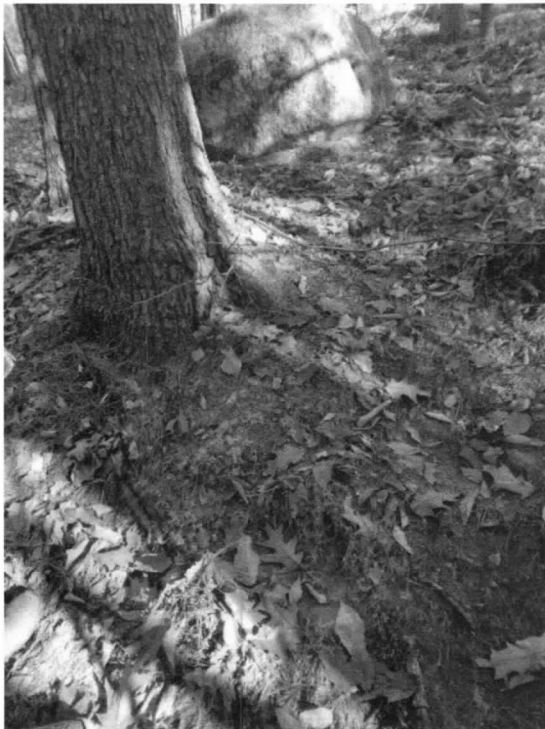
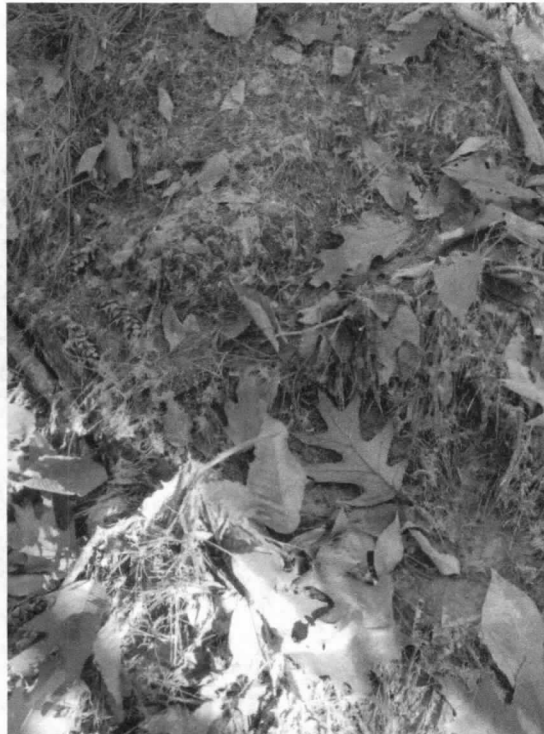
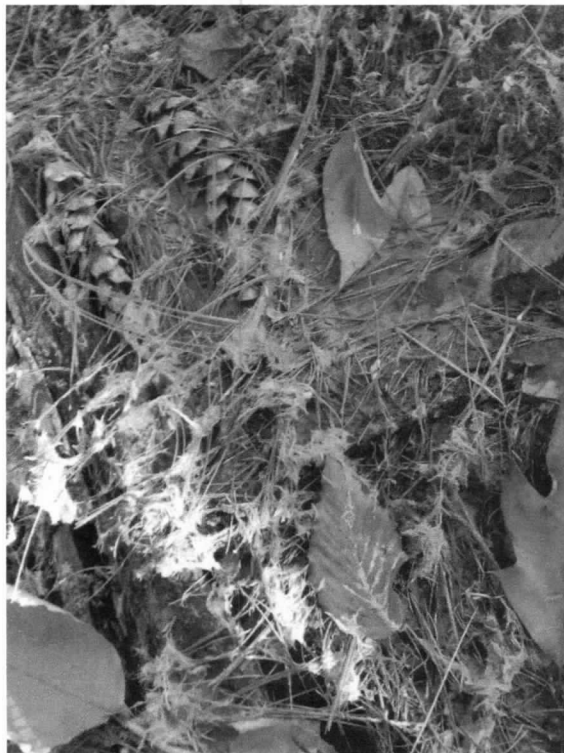
At the top of the fire road is a rock wall. Adjacent to the rocks, there is hydroseed slurry.

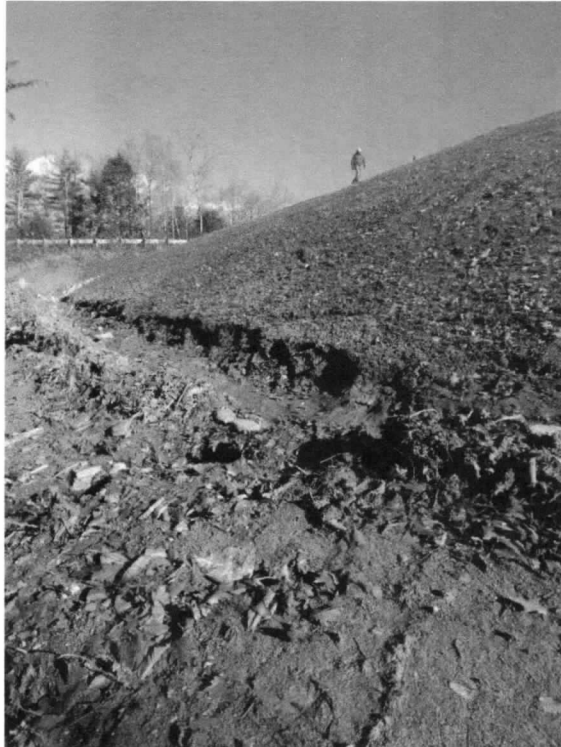
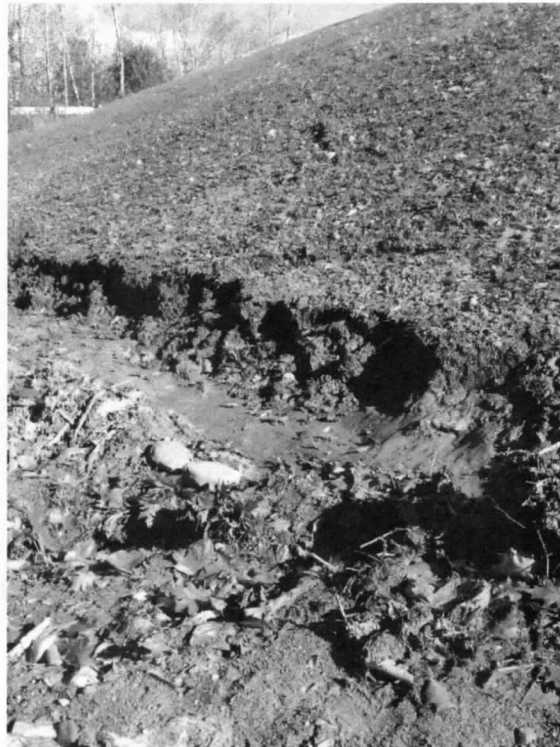
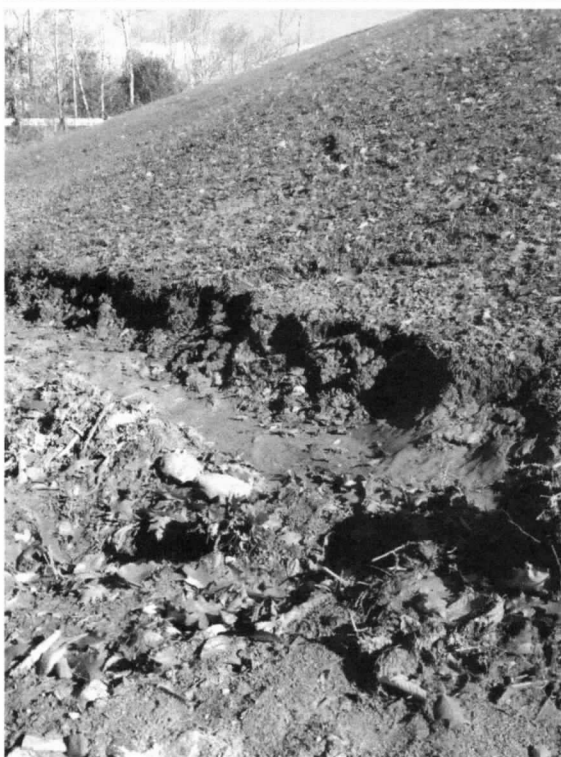
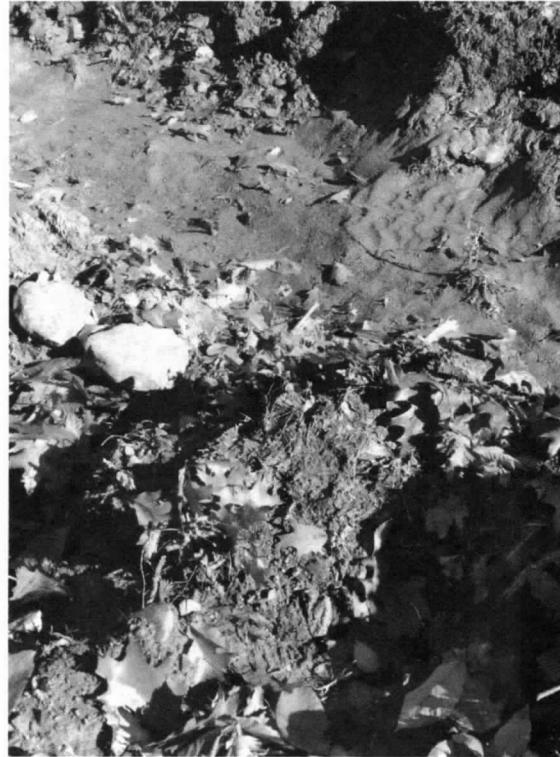
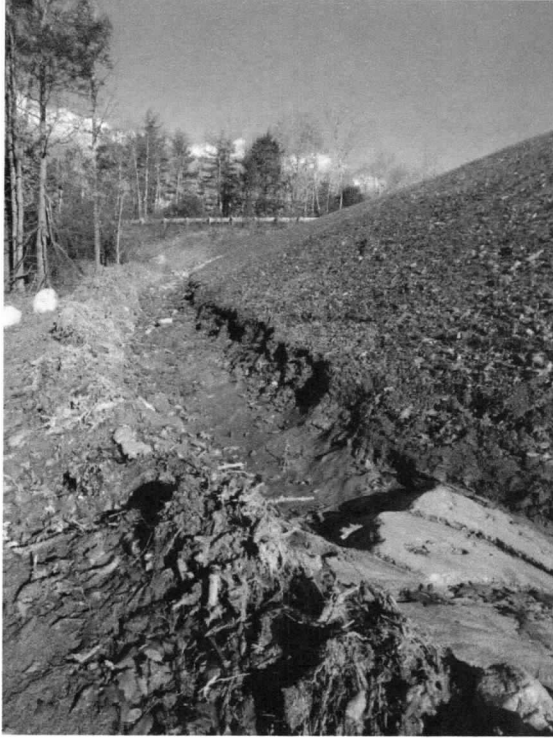
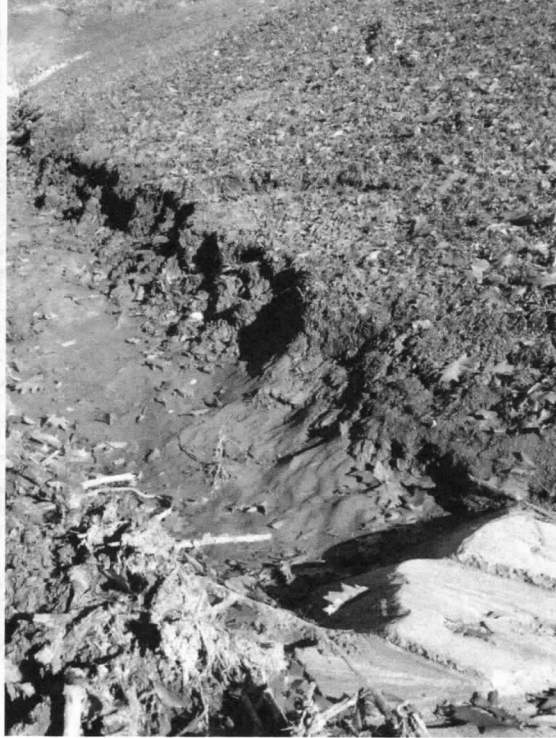
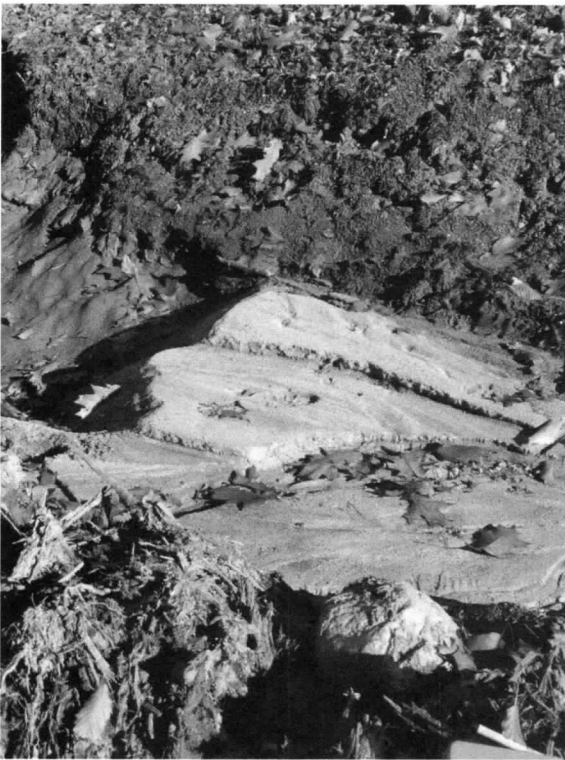
We looked at the swale at the base of the slope next to the rock wall. We observed sand at the end of the swale. The berm around the swale showed evidence of breakthrough. The road observed next to the guardrail is Peregrine Way.

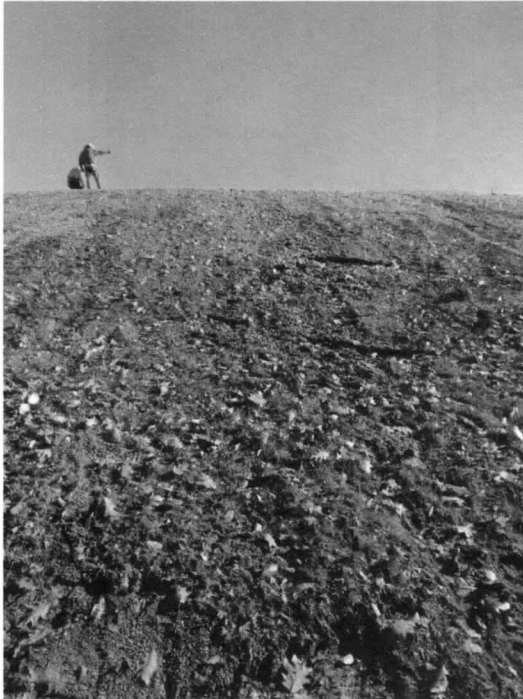
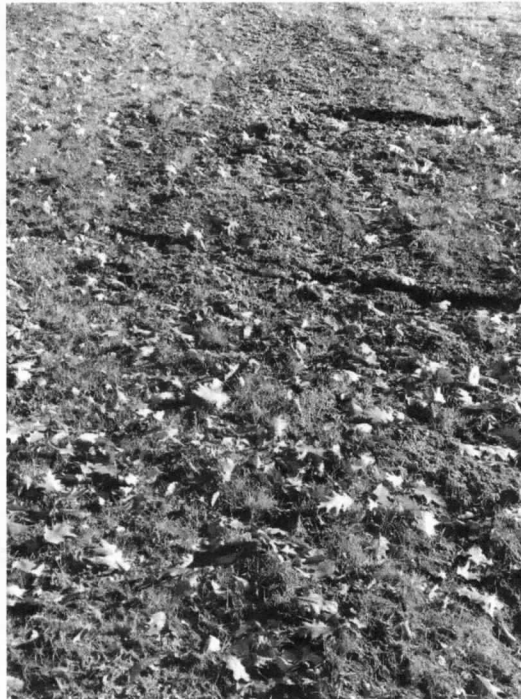
Looking up slope, channels are evident.

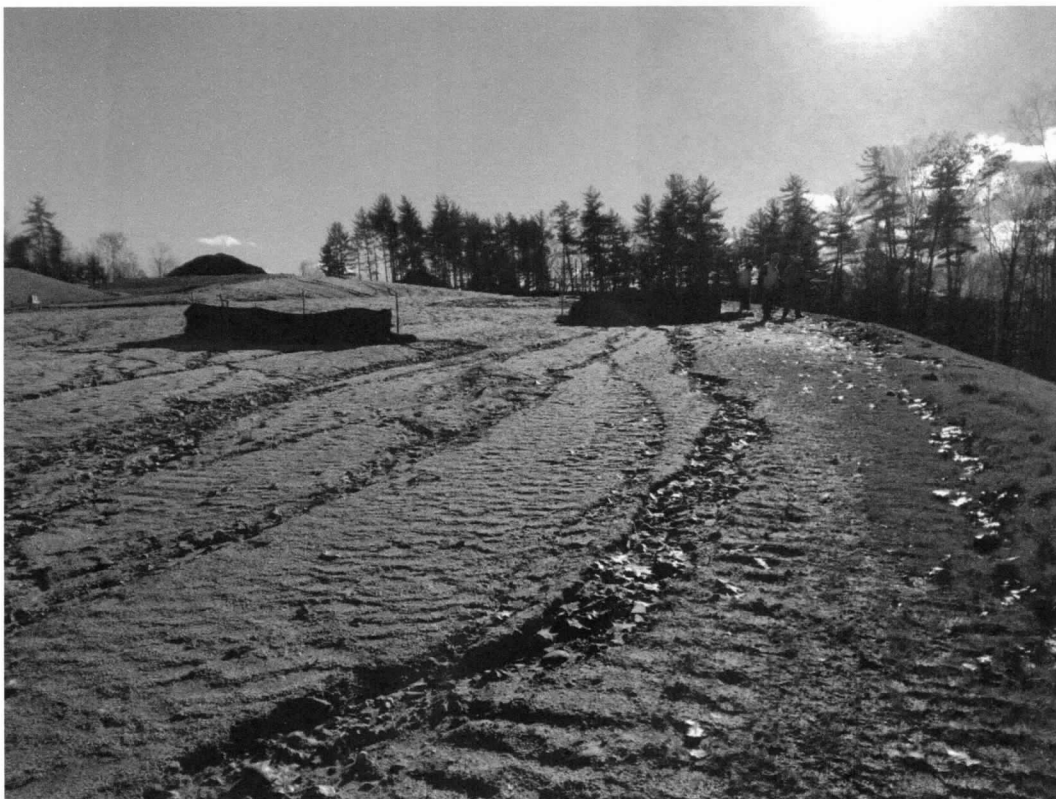
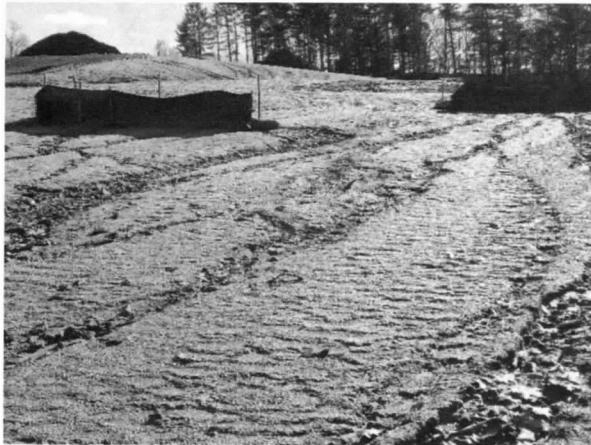
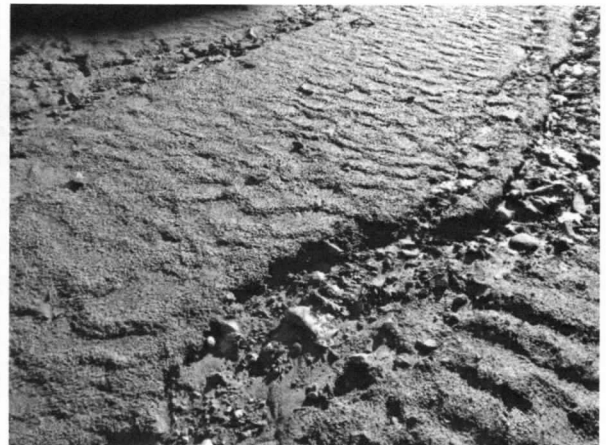
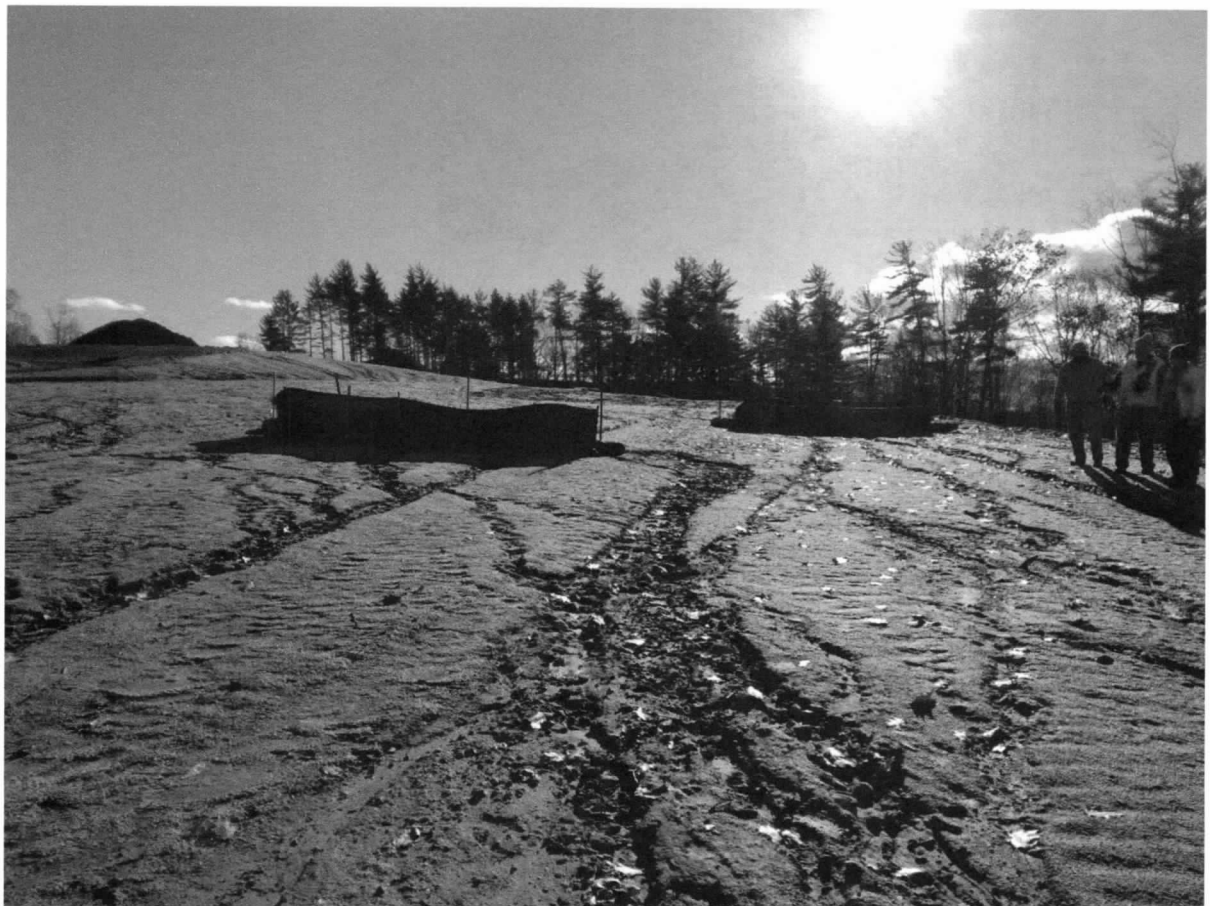
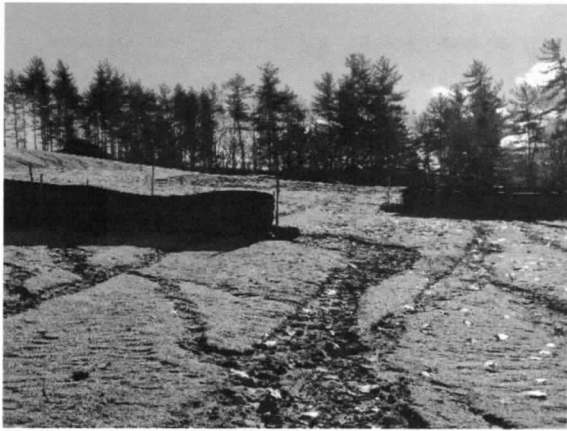
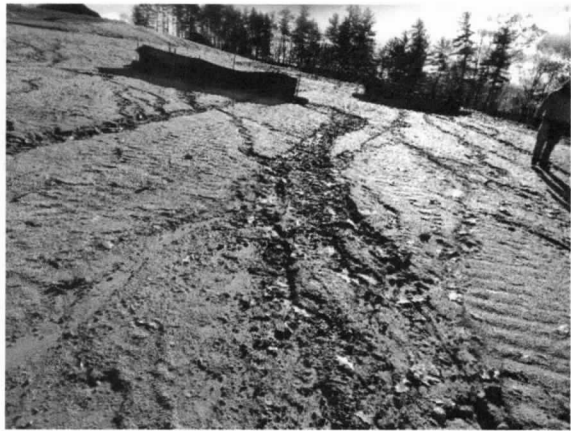
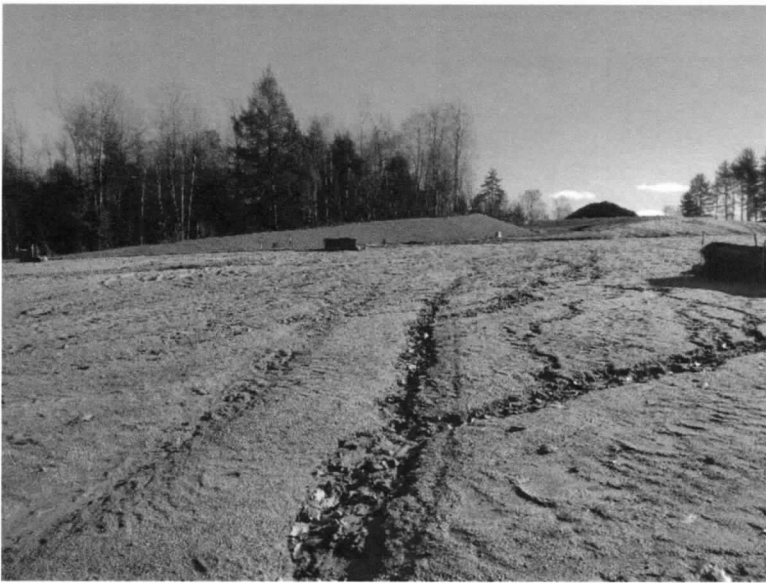
Silt fence at the top of the slope.

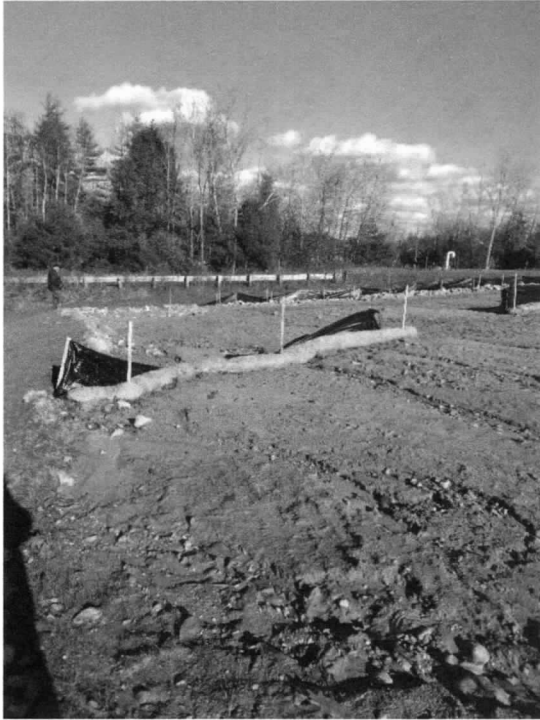
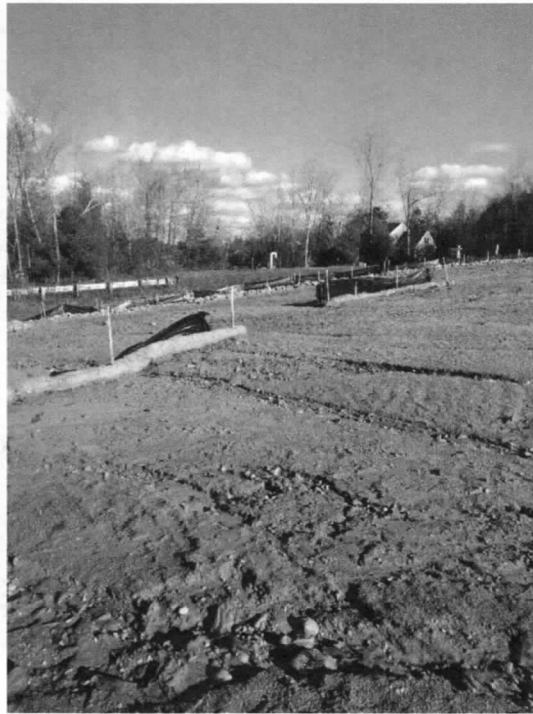
Silt fence and waddle down slope toward the road, Peregrine Way.

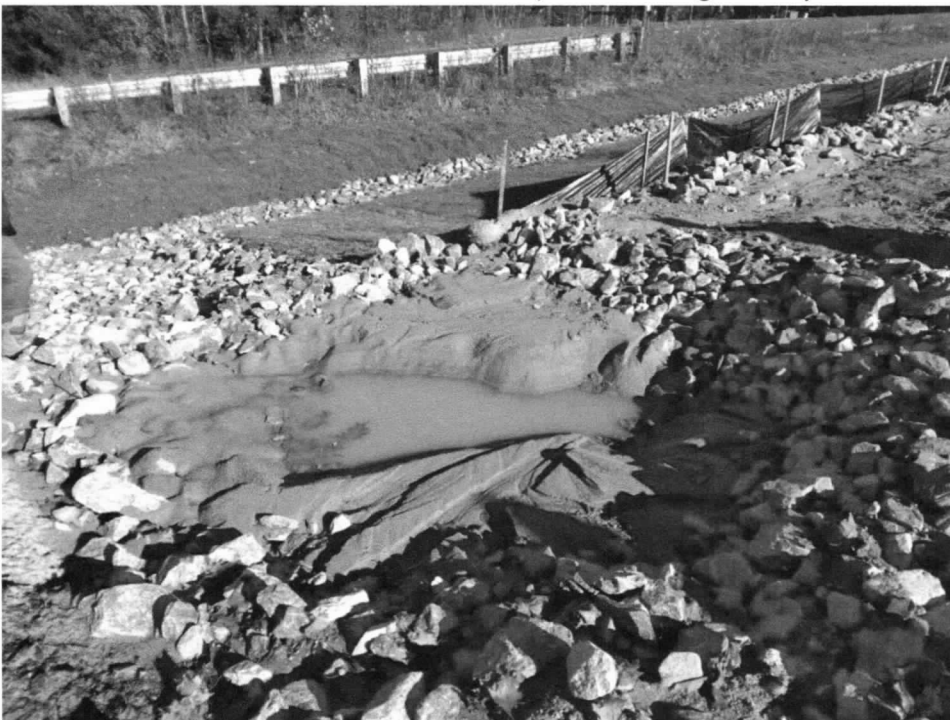
The detention basin had a lot of silt. This is adjacent to Peregrine Way.

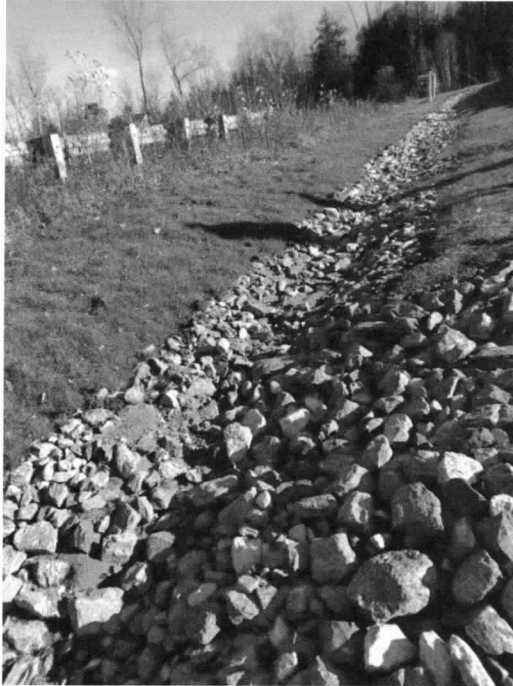
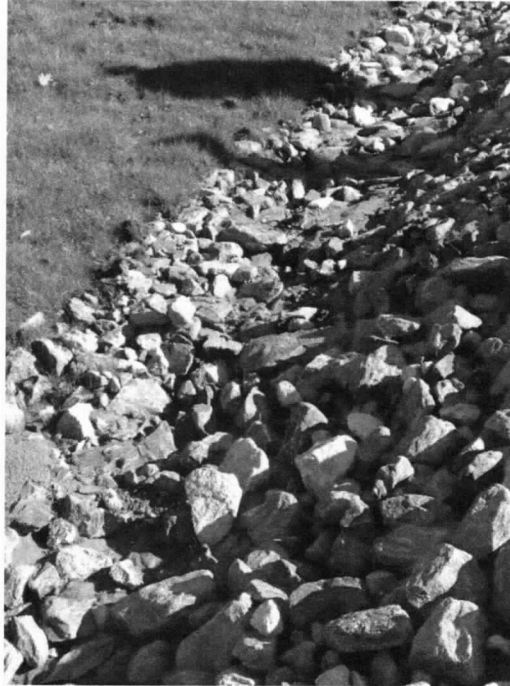
There was silt in the swale

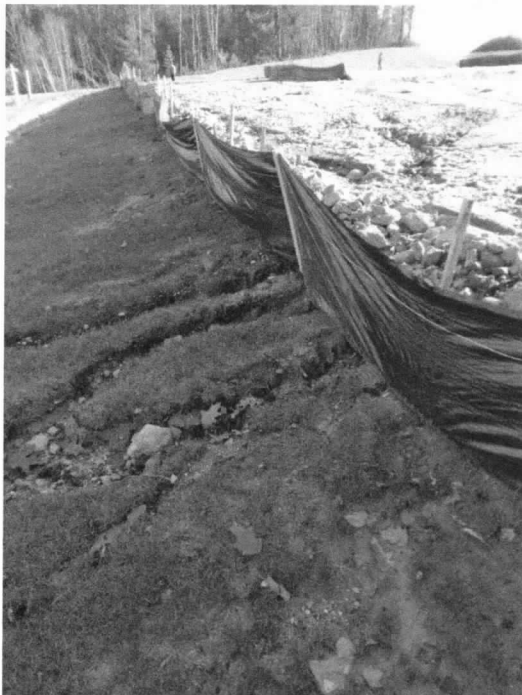
Channels under the silt fence.

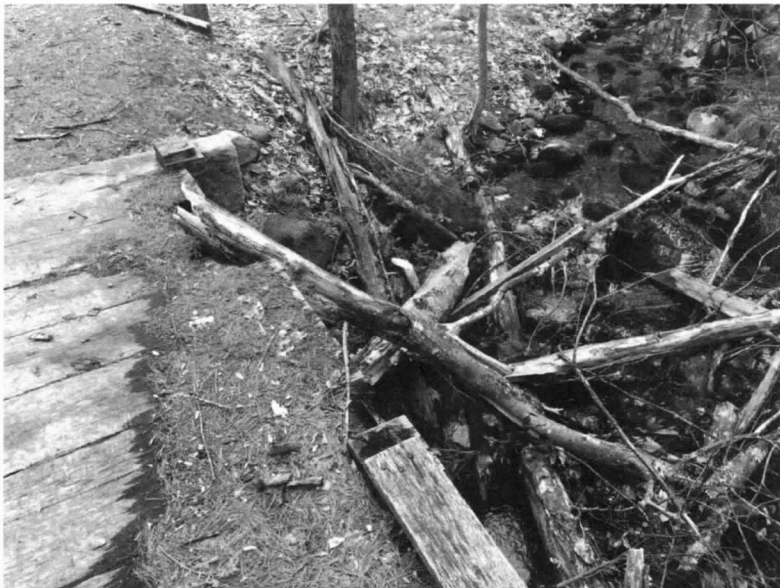
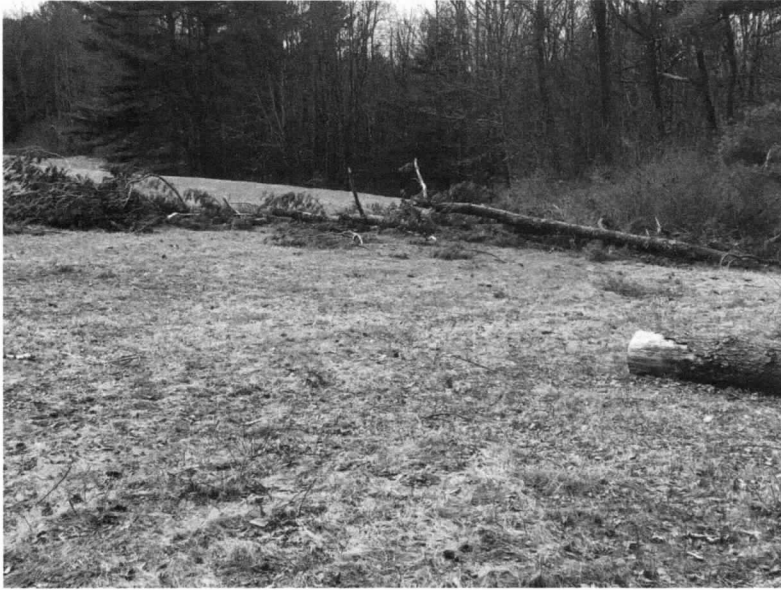
- Comments (users, anything unusual): Walking bridge railing heading into the Frog Pond, has been damage from a piece of falling tree. Also South West of the dam in Wilton's portion of field a portion of pine tree has blown over into the field.
